SURVEY REPORT #4468

Date: December 8, 2008

Vessel Name: "ILLUSION"
Type: Auxiliary Sail
Service Area: San Francisco Bay
Official #: USCG Document # 618722
Hailing Port: Lake Tahoe, CA
Certificate aboard / numbers attached: Yes / Yes
Hull ID #: ZCC34232M80C

Purpose of Survey: Condition and value for pre-purchase purposes

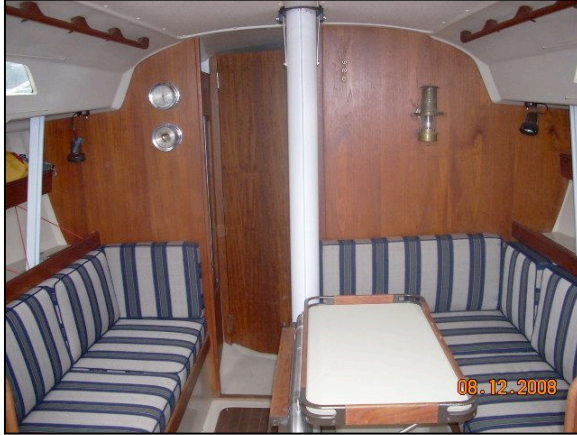
View of salon

- The interior is generally clean and uncluttered. Upholstery is recent – there were no signs of water intrusion. Interior shows good care and maintenance.

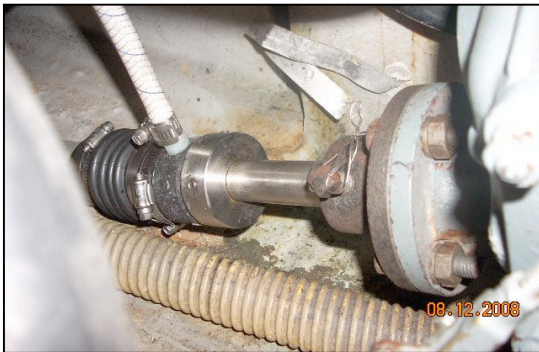
Packless shaft seal

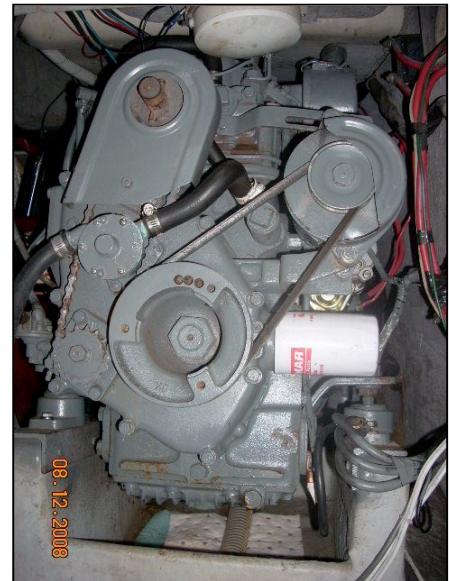
Comments: Engine has a recent documented re-built (2007) with block replacement, re-painting and general overhaul. It was run for about 1 ½ hours during sea trial and performed satisfactorily.

Front view of engine

4. Suggest keeping an engine maintenance log - installation of an hourmeter would facilitate keeping track of engine use for this purpose.

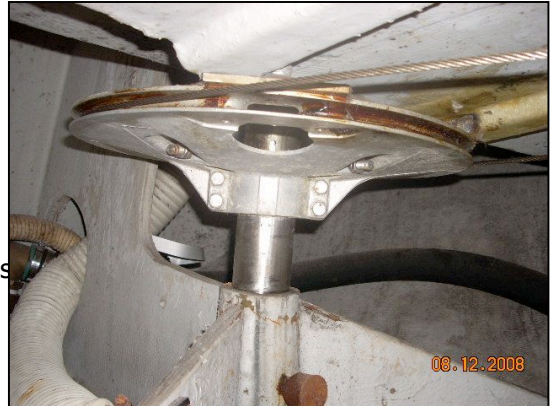
Comments: Systems well installed and operational.
Eng.Rm.Ventilation: SIMER 12v engine space exhaust blower
Insulation: None
Wheel/Tiller: EDSON pedestal and SS wheel destroyer type, 32" dia.
Steering Gear: Cable to radial drive wheel
Emergency Steering: Aluminum tiller
Rudder: Foam filled FRP
Rudder Post/Gland: FRP tube and bearing, grease fitting
Bilge Pump(s)-Manual: WHALE Gusher diaphragm in cockpit

Part of the steering assembly

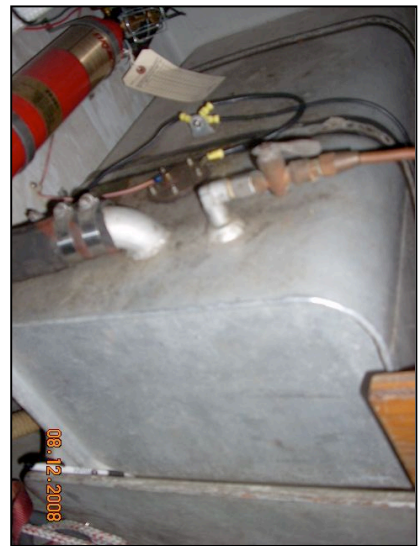
Accessibility/Condition: Good / appears good

Fuel tank

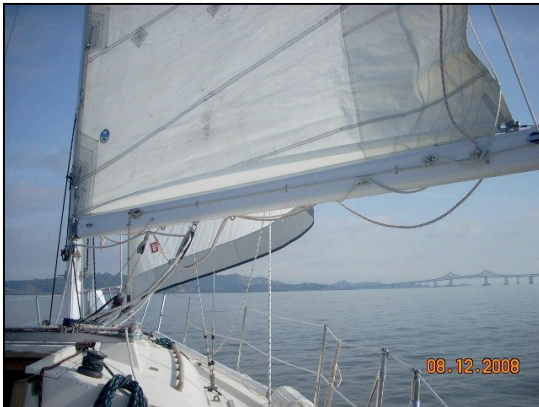
Comments: The rod standing rigging was replaced in 1995 and rod ends were redone in 2005.
 Mainsail and furling jib are recent and in good condition – vessel performed well during sea trial in light wind conditions.

During sea trial

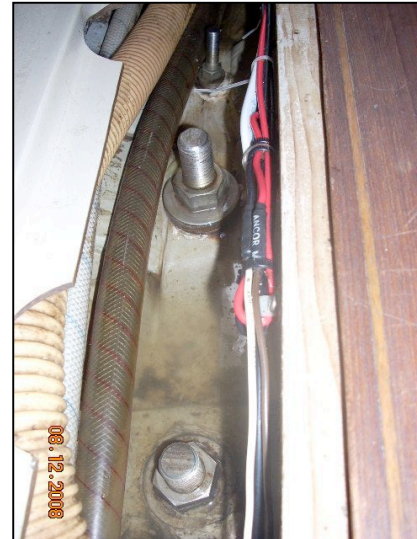
Keel bolts: 1" SS – Appear good at heads, no visible corrosion
Standing Rigging: NAVTEC SS rod
Condition: Appears good from deck
Terminals: Swaged
Turnbuckles/(pins?): SS Bronze / yes
Chainplates/Stem: Stainless steel
Spinnaker Pole/Reaching Strut: Aluminum, white enamel
Running Rigging: Dacron braid
Condition: Good
Winches: All BARIENT: (2) #28 (primary), (2) #25 secondary, (3) #18, (3) #10
Rigging details: Single spreader, masthead rig

Keel bolts
